2010

## Jewish Heritage Sites and Monuments in Moldova

Samuel D. Gruber

United States Commission for the Preservation of America's Heritage Abroad

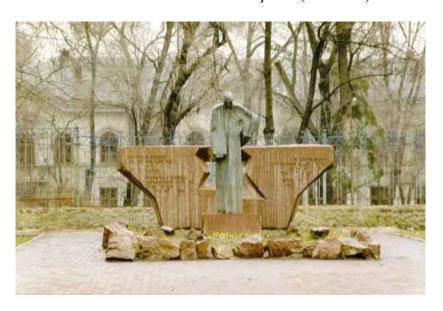
### Monument to the Victims of the Chişinău (Kishinev) Ghetto

The Chişinău Ghetto was established in 1941. On April 22, 1993, a monument to those imprisoned there was placed on the border of this ghetto at Jerusalem 3000 Street. The monument, designed by sculptor Naum Epelbaum (b. 1927) and architect Simeon Shoihet (b. 1931), consists of a large bronze standing figure of a praying Jew, with his left hand on his heart and his right hand holding Scripture, symbolizing the suffering of the prisoners. The figure is on a pedestal, and set against a broken red granite wall, at the center of which is a void in the shape of a shattered *Magen David* (Star of David). Memorial ceremonies are held here on Yom ha-Shoah (Jewish Memorial Day for Holocaust victims) and at other times.

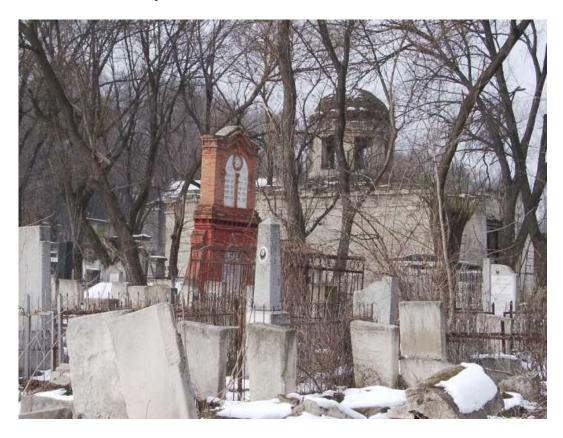
## **Old Jewish Cemetery**

The very large Jewish cemetery in Chişinău, then the single largest Jewish site in the country, is still in use and it is frequently visited. The approximately 100 hectare area is surrounded by a continuous masonry wall with a gate. It contains more than 20,000 graves, which date back to the 17<sup>th</sup> century. Gravestones and markers are made of marble, granite, limestone, sandstone, slate and other materials. Some graves are marked with ornate structures in the form of mausoleums. Many graves have metal fences around them; others have portraits applied to the stones, as well as other decorative items. There is a monument to the victims of the Holocaust, and the ruins of a pre-burial house.

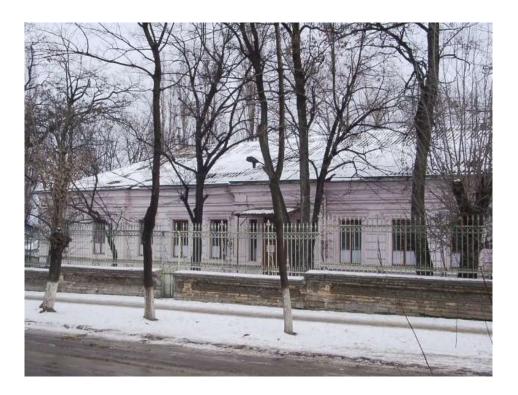
The Jewish Hospital was established at the beginning of the 19<sup>th</sup> century. It was originally a two-story brick building that occupied a large area along the slope between the southern part of Nicolayevskaya Street and the northern part of Andreyevskaya Street Initially, it was a branch of the Zamsky Hospital, managed by the Social Welfare Service of the Ministry of Internal Affairs (of Russia). In 1870, the Jewish Hospital became a separate medical institution with its own administration. The hospital constitution was approved on July 3, 1899 by the General Secretary of the Ministry of Internal Affairs of Russia, Prince A. Obolencky. It stated that the hospital's mission was "to provide medical help for the patients of Jewish nationality, both men and women, the residents of Chişinău, and if there are free places medical help can be granted for the Jews living in other towns and settlements, and also for patients of other religions." The hospital was officially designed for 110 beds (50 for men, 55 for women, five reserved), but overall it accommodated up to 200 patients. Hospital services expanded in 1906, when an emergency room was opened and midwifery classes and a school for nurses were set up under hospital supervision. They continued until 1917.

After the Second World War, the hospital was taken over by the state. The buildings are now in very poor condition.

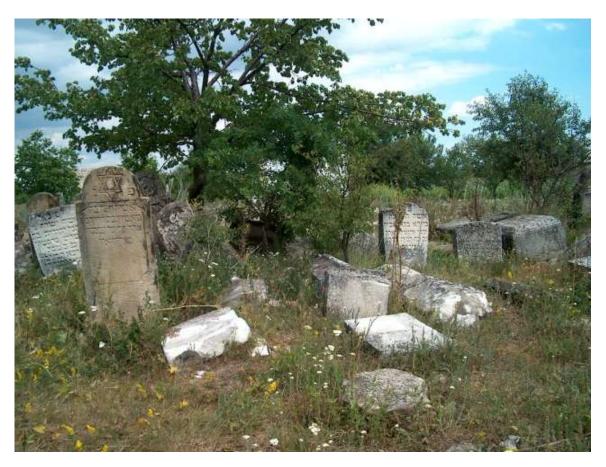
**Jewish Cemetery**

The cemetery occupies a site about 1,500 square meters in size and contains more than 700 extant gravestones. The oldest gravestones date from the 18<sup>th</sup> century. The cemetery is no longer in use and is only rarely visited. There is no caretaker, and there has been no care for the site for many years. Although the condition is poor, less than a quarter of the surviving stones are toppled or broken. Water drainage and vegetation overgrowth are constant problems disturbing graves in the cemetery.

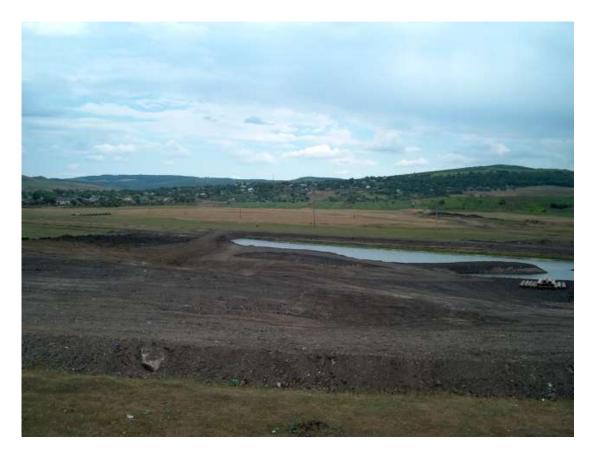
#### **Execution Site**

The Jews of Alexandreni were murdered in June 1941, when they were rounded up and marched to fields outside the village and executed. There are no signs or markers to indicate the execution site, and only few local residents can show its location.

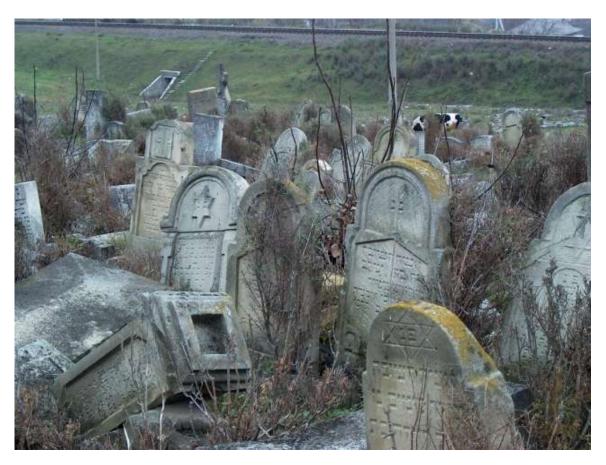
The enormous Jewish cemetery in Bălţi is one of the largest and most impressive Jewish sites in Moldova. On a site of 100 hectares, it is approximately the size of the cemetery in Chişinău. It contains a monument dedicated to the victims of the Holocaust and more than 20,000 gravestones. The gravestones are made of a variety of materials, and are fashioned in many styles. The cemetery is surrounded by a broken fence. The site is frequently visited and it has a regular caretaker. Restoration work, including cleaning of the stones and clearing of vegetation, are regularly carried out on the site.

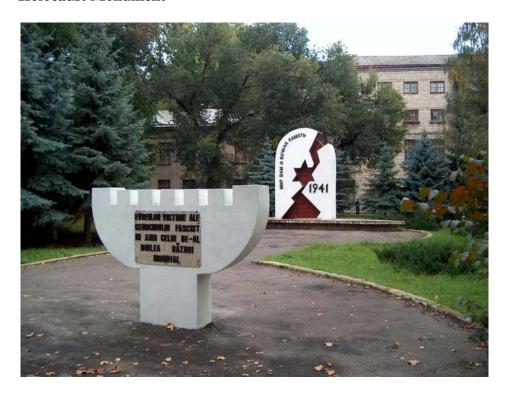
#### **Holocaust Monument**

The Holocaust monument was erected in the late 1990s on a site where more than 1,000 Jews were killed. The monument is in two parts. In front is a vertical stele in the shape of the menorah, with a commemorative inscription. Behind is a tall stele in the shape of a round-headed gravestone. In the center is a Star of David, through which runs a crack. On one side of the crack is the date "1941." The monument and site are recognized as a protected historical site and are kept in good condition.

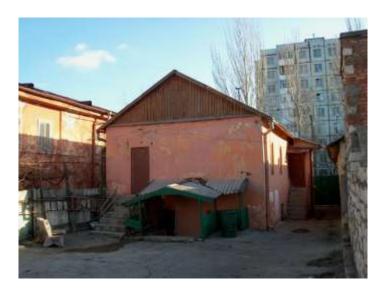
#### Salesclerks Synagogue

This two-story building was constructed early in the 20<sup>th</sup> century. After the Second World War, a plan to turn it into a warehouse for the storage of pork was successfully

opposed by local Jewish leader Perets Leonid and the building was instead used by a bicycle club and rented out as flats. Following the reestablishment of the Jewish community in 1989, the building was returned to its original purpose. Today, it serves as Benderi's only synagogue.

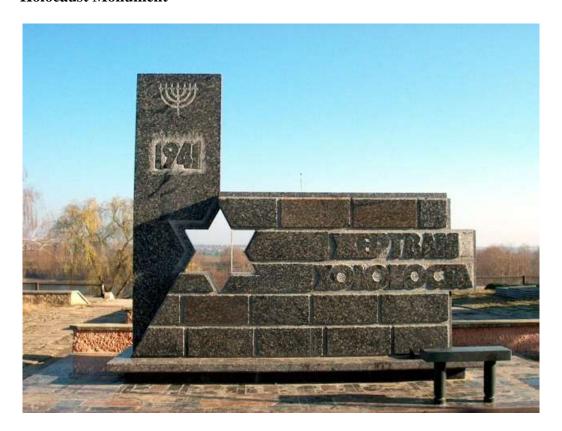
#### **Holocaust Monument**

Built in 2002, the monument is located on the bank of the Dniestr River where about 1,000 Jews were killed and then thrown into the river. The area is designated as a historical and protected site and is accessible from a public road. Volunteers from the community occasionally clean the area around the monument which is still in excellent condition.

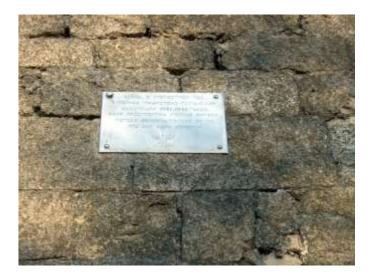
#### **Execution Site near Benderi Fortress**

In June 2001, a memorial plaque was established at a spot where more than 600 Jews were executed between July and September 1941. The plaque reads: "Here, in the fortress ditch, during the Fascist-Romanian occupation in 1941-1945, people of peace from Benderi were shot merely because they were Jews."

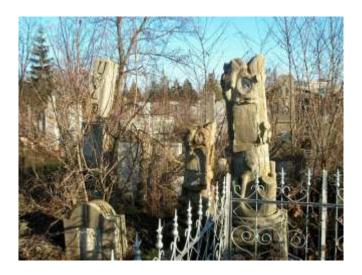
Benderi's large Jewish cemetery contains over 5,000 gravestones, and is protected by a continuous stone wall with a lockable gate. The stones are in poor condition with more than three-quarters of the stones toppled or broken. Even though the cemetery has a regular caretaker and has been cleaned several times in recent years, vegetation remains a continuous challenge. Restoration work was carried out in 2001. Over the last ten years, the cemetery has suffered from several acts of vandalism. The earliest gravestones date from 1913. There is also a monument to the victims of the Holocaust. The site is visited frequently.

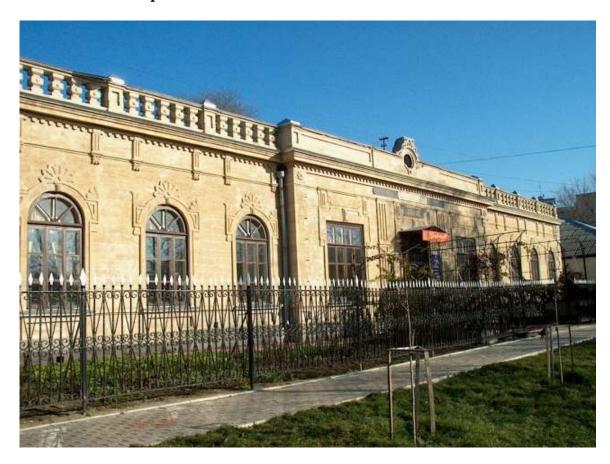
The former Jewish Hospital was constructed in 1889 in the typical style for official institutions of the time. The long main building has Italianate elements common in palace and villa architecture – including rows of large arched windows with decorated moldings, and a balustrade at the roof level. The hospital served as a free medical institution, run by the Jewish community, until 1939. After the Second World War, the building was taken over by the state. It now contains a medical school. The site is in good condition overall, and has retained its original form despite several renovations.

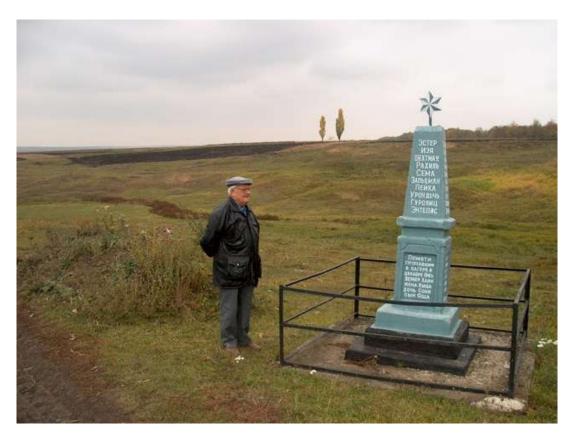
#### **Monument to the Victims of Holocaust**

On July 7,1941, the entire Jewish population of Berlintsy was executed in the fields outside the town. In 1952, a memorial obelisk was established on the site of their deaths. Semion Katerberg, whose family was killed in the execution, cares for the monument and, thanks to his efforts, it is kept in good condition.

While the creation and maintenance of the monument indicates the site of the massacre, further commemorative work is needed to protect the site of the nearby graves of the Holocaust victims.

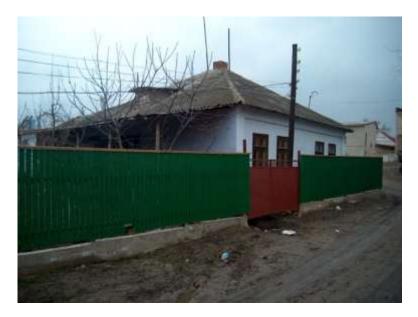
The former synagogue, a small one-story building, was built at the beginning of the  $20^{th}$  century. It was later sold for use as private housing. The current owner maintains the former synagogue and only minor changes have been made to the building.

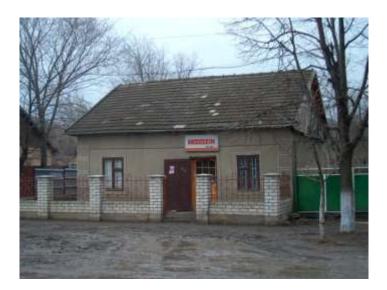
## Former house of prayer

The prayer house was reestablished in the private home of the town rabbi after the Soviet authorities banned services in the local synagogue. A special room for religious ceremonies was set up in the house. The current owner has transformed the house into a grocery shop. The interior and the façade have been significantly changed.

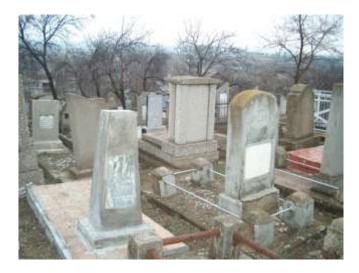
The cemetery occupies an area about 20,000 square meters in size, and contains up to 5,000 gravestones and a monument to the Holocaust victims. The gravestones date to the 18<sup>th</sup> century and about half of them are toppled or broken. Cleaning and restoration efforts are often carried out at the cemetery and there is a regular caretaker who maintains the site.

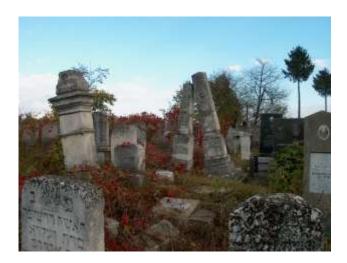
The cemetery, which occupies an area of about 5,000 square meters, is still in use, but it is poorly maintained. There are more than 500 extant gravestones, some dating from the 18<sup>th</sup> century. The cemetery is surrounded by a broken fence that needs to be restored. More than a quarter of the stones are toppled or broken, and significant amounts of vegetation cover the site.

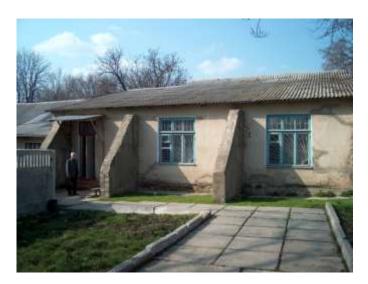
### Former Synagogue

After the Second World War, the synagogue served as a shop and a local school. The Jewish community regained control of the building in 1990, and since then it has been used as a Jewish community center and chamber of commerce.

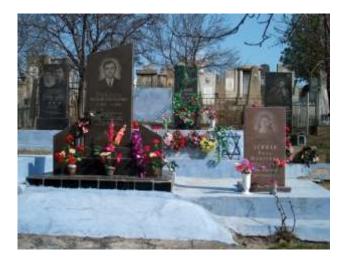
The cemetery occupies an area of about 10,000 square meters and is surrounded by a continuous masonry wall with a gate that can be locked. The cemetery contains about 1,500 gravestones, but more than 75% of them are toppled or broken. The earliest gravestones date from the 19<sup>th</sup> century, but there is also a fairly large section of new graves, many of which have portraits of the deceased engraved upon the large polished

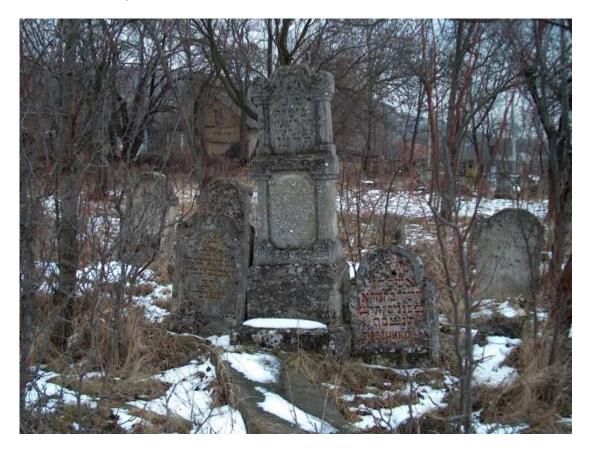
The cemetery occupies an area of about 15,000 square meters and there are probably close to 5,000 gravestones on the site, but more than 50% of them are toppled or broken. The oldest gravestones date to the 18<sup>th</sup> century. The cemetery was once surrounded by a wall, which is now broken in many places. There is no caretaker and the cemetery is completely neglected.

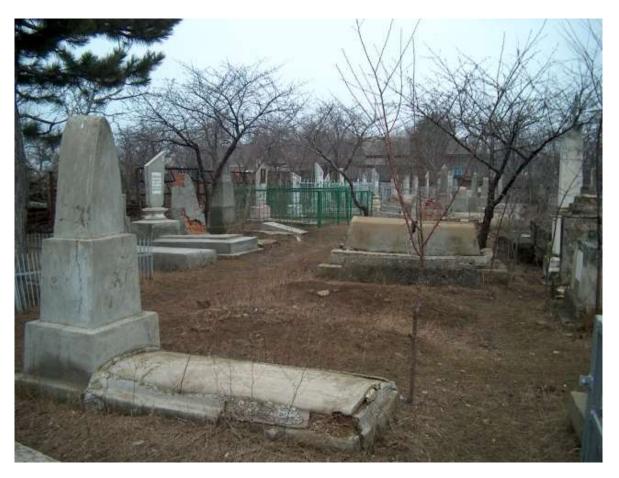
This fenced cemetery occupies an area of approximately 5,000 square meters and has about 500 extant gravestones. About three-quarters of these are toppled or broken. The oldest graves are from the early 20<sup>th</sup> century. The cemetery is maintained by a regular caretaker, but vegetation overgrowth still causes seasonal problems and can make access to individual tombs difficult. The local Jewish community helps take care of the cemetery. In 2002, restoration of the fence was funded by former inhabitants of the town now living in Israel.

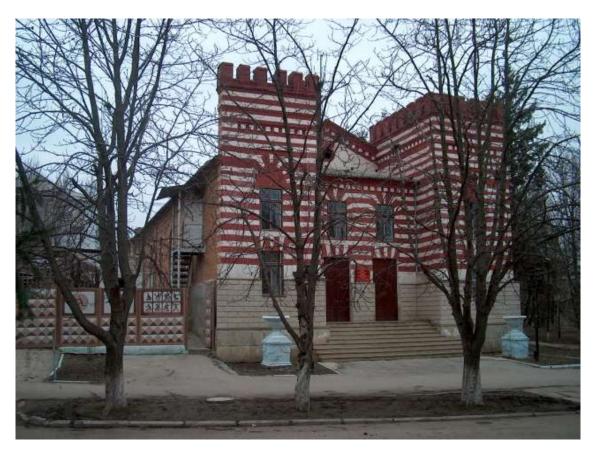
Constructed in 1924, the synagogue is a strikingly exotic element in the townscape. Its red and white striped façade is marked by two large square crenellated towers which protrude toward the street, with a wide stairway ascending between them to the building's triple entranceway.

The building was taken over by the state after the war, when it became a "Palace of Culture." In 1960, the building became a sports academy. In spite of the demolition of some internal walls and other original elements, the building is in overall good condition.

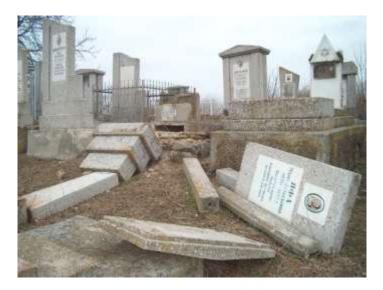
The cemetery occupies an area of about 2,000 square meters and contains around 250 extant gravestones. There is also a monument to the victims of the Holocaust. More than half of the stones are toppled or broken. The oldest stones date from the 19<sup>th</sup> century. The site's only protection is a broken wall; it has no regular caretaker. Vegetation poses a serious threat to this cemetery.

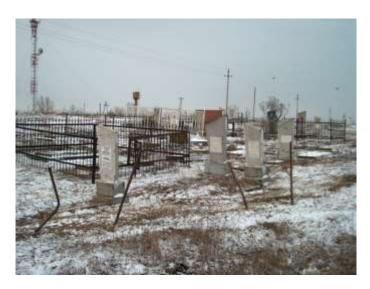
The Jewish cemetery in Comrat is less than 1,000 square meters in size. It was surrounded by a chain-link fence – but almost all sections of this, except a broken gate,

have been stolen. The cemetery contains about 50 gravestones, about 25% of which are broken or toppled. The oldest stones date from the 19<sup>th</sup> century. Many have small oval portraits attached, but in most cases these portraits have been damaged or completely removed. Some of the burial plots are surrounded with little metal fences – though many of the fences have been broken. The site is overgrown, and it has obviously been frequently vandalized. There is no regular caretaker.

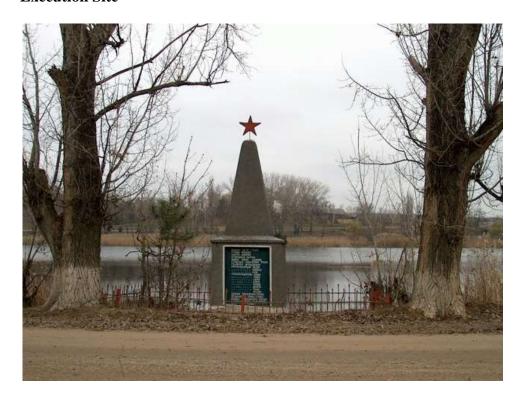
The monument on the site was built in the 1970s for these war victims, and it is a designated as a protected historical site. Although local residents and authorities keep the area around the monument clean, it needs basic repairs.

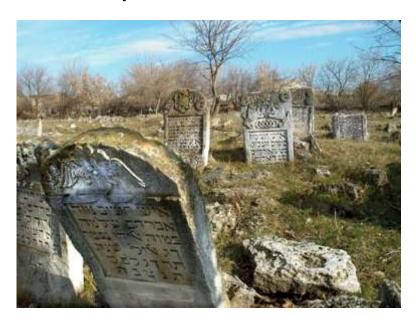
The cemetery is over 30,000 square meters in size and it is surrounded by a fence with a gate. It contains more than 500 stones, many of them finely carved. There is also a monument to the famous Hasidic rabbi Mendel Mabar, and a memorial plaque for the old Jewish cemetery of Dubăsari. Although most of the older stones are toppled, the

cemetery has a regular caretaker and its overall condition can be described as fair. Since 1993, restoration work has been done every year.

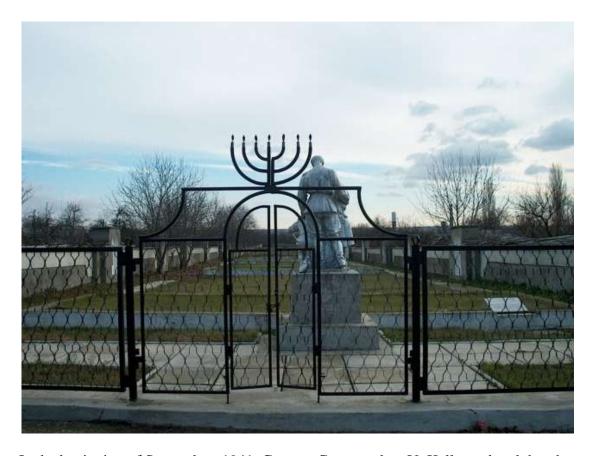
#### **Execution Site / Holocaust Monument**

In the beginning of September, 1941, German Commandant V. Keller ordered that the local Jewish population from the nearest villages – Lunga, Magal, Korjevo, Bolishoi Fontan – and Jews from the Dubăsari Ghetto, dig pits (14 meters in length and four meters deep). An eyewitness to these events, local resident Petr Ignatiev, remembers that "...for nearly all of September of 1941 Jews by groups of 10-20 were undressed to their underwear, and urged along from the tobacco factory to the prepared pits... After this the Nazis forced them to their knees and, by command of the chief, shot them..."

The monument was established in 1989 to commemorate the 18,000 Jews who were killed by the Nazis on its site. The site is regularly maintained.

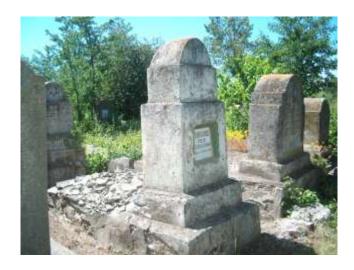
The Jewish cemetery of Floreşti occupies an area of approximately 7,500 square meters and is surrounded by a broken masonry wall. It contains over 1,500 gravestones, but more than 75% of them are broken or toppled. The oldest stones are from the 19<sup>th</sup> century. The cemetery is still in use and it is frequently visited, but some of the gravestones have been destroyed by vandalism, and overgrowth is a seasonal problem. Local authorities and individuals occasionally clean the site, but there is no regular caretaker.

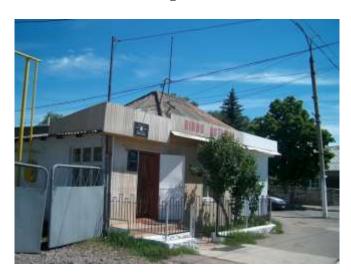
### Former Jewish Building

The house used to be owned by a local Jewish resident, Doctor Frikeutsan Boris Zinovievich, was constructed in the 19<sup>th</sup> century. A notary's office is located there today. The building is in good condition.

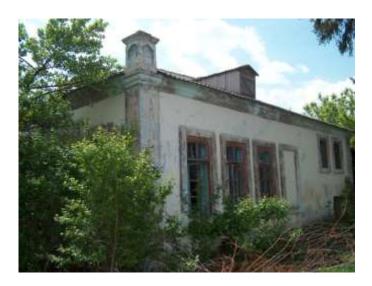
The single-story former synagogue, built in 1910, was converted into a school after the Second World War. It is in very poor condition.

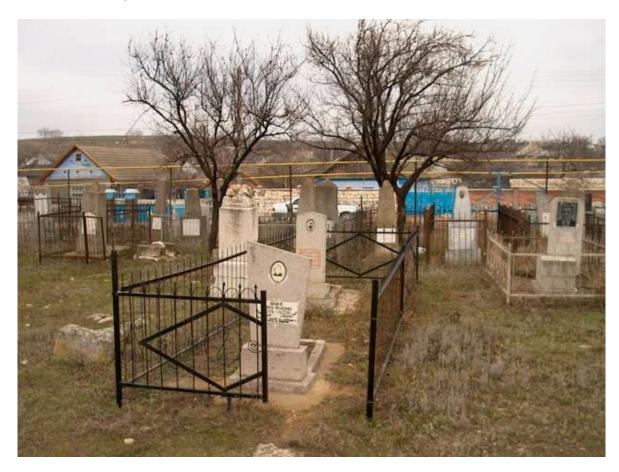
### **Jewish Cemetery**

The cemetery is located in Krasnogorka, in the northern part of Grigoriopol. It contains about 100 stones, as well as a monument to the victims of the Holocaust and Jewish soldiers. The area is protected by a fence with a gate. A nearby housing development has encroached upon the cemetery. The cemetery does not have a regular caretaker, but it is occasionally cleaned by locals. The vegetation overgrowth is only a seasonal problem which prevents access to some of the graves.

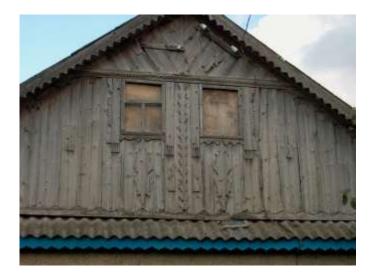
#### Jewish House

The only surviving house built by Jews in Grimancauti is still in good condition. Jews in the village were mostly craftsmen, and the designs of their houses differed from those of other rural dwellings. This house is divided into two parts, with a door in the middle, and with half the floor serving as a living area and the other half as a workshop. There were also cellar storerooms for fruit and vegetables – whereas Moldovans tended to store these in holes dug in their courtyards. The roof of the house is decorated with traditional Jewish carvings. Despite several small changes, the house has mostly kept its Jewish characteristics.

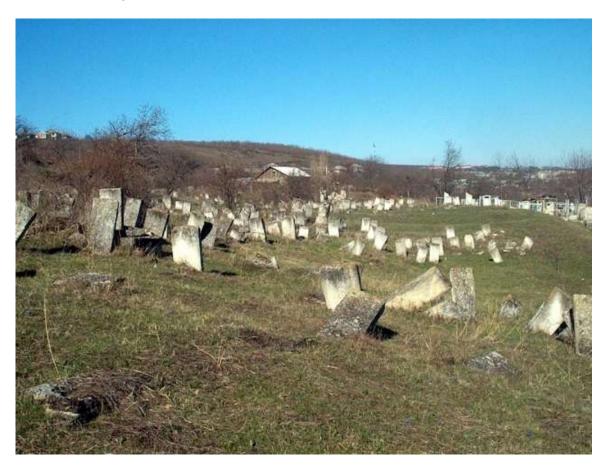
The area of the Jewish cemetery in Hinceşti covers an area of 40,000 square meters and contains more than 500 gravestones, about half of which are toppled or broken. The oldest stones are datable to the second half of the 19<sup>th</sup> century. The cemetery is surrounded by a fence and has a gate that can be locked. The site is occasionally cleaned, but vegetation overgrowth is a constant problem. Some restoration work, including repairing broken stones and clearing of vegetation, has been carried out.

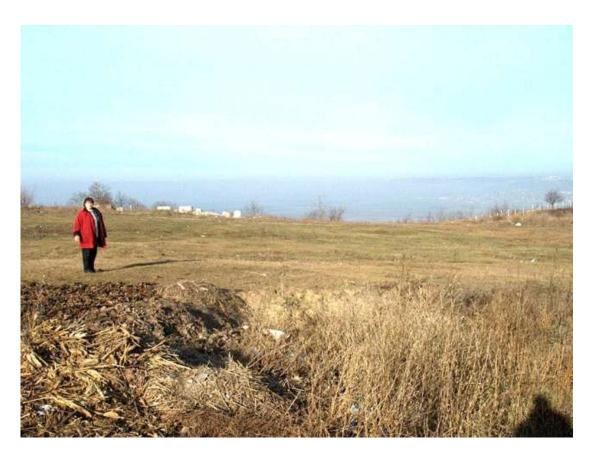
### **Execution Site**

When Isakovo was captured by the Romanians in July, 1941, 60 Jewish inhabitants of the village were forced to dig a large hole, and then they were executed at the site. Local townspeople Guzhuman Paraskovia Dmitrievna and Guzhuman Anna Trofimovna can still point out the location of the mass grave. In 1944, the remains of the bodies were reburied at the Orhei Jewish cemetery in a communal grave, where a monument was erected. In Isakovo, there is no marker commemorating the massacre. The killing site is in an unmarked area about 100 square meters, located in a small ravine at the edge of the village. There are plans to build new roads and housing on the site.

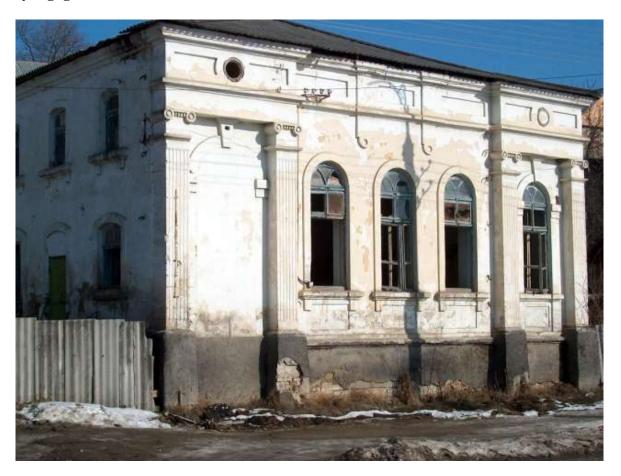
The attractive, classical-style synagogue was built in the middle of the 19<sup>th</sup> century and it served the Chabad community until 1940. After the war it was used as an archive and warehouse, and it was returned to the Jewish community in the early 1990s. The building is in very poor condition and it is continuing to deteriorate. Still, most of its original exterior plaster decoration remains intact and can be saved. The local Jewish community does not have the means to restore it.

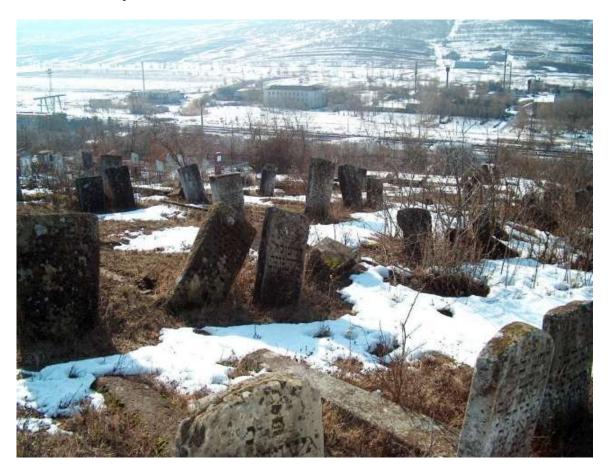
The Jewish cemetery is about 60,000 square meters, and is surrounded by a broken fence. It contains over 500 gravestones, almost half of which are toppled or broken. The oldest stones date from the 19<sup>th</sup> century. There is a monument to the Holocaust victims, which was recently restored with private funds. The cemetery is still in use, but receives little maintenance. It is occasionally cleared by local residents, but overgrowth is a constant problem. The site is also in a landslide zone, where there is constant erosion and the threat of earth slides.

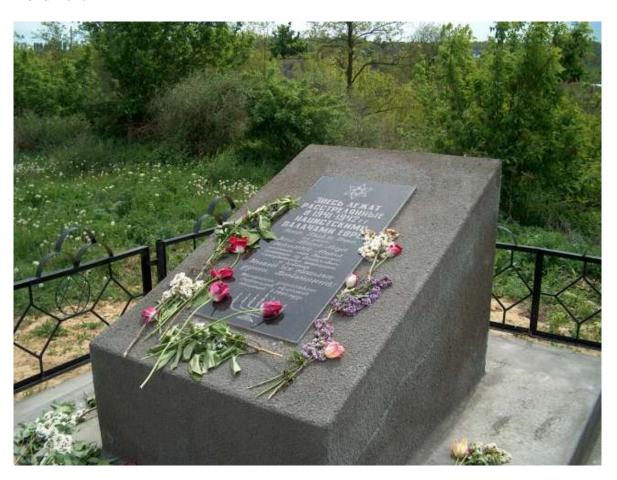
### Monument

A memorial monument commemorating fifteen Jews killed here during the Second World War was inaugurated in 2002. It is a protected site and there are regular commemorative ceremonies.

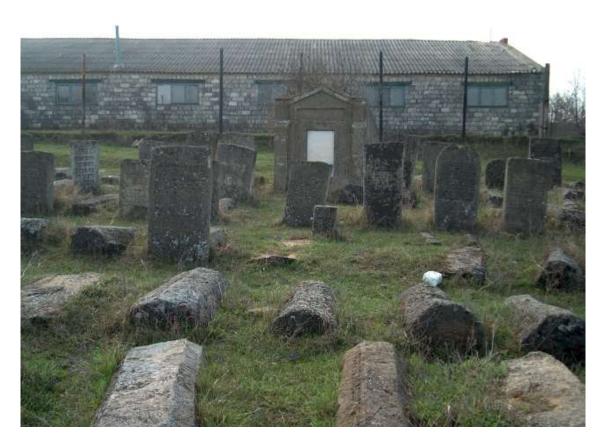
The 1,500 square meter area of the Jewish cemetery in Leova is surrounded by a fence with a gate. There are more than 1,000 extant gravestones; the oldest from the 17<sup>th</sup> century. More than half of the stones are broken or toppled and vegetation overgrowth prevents easy access. There is no caretaker and the cemetery is rarely visited.

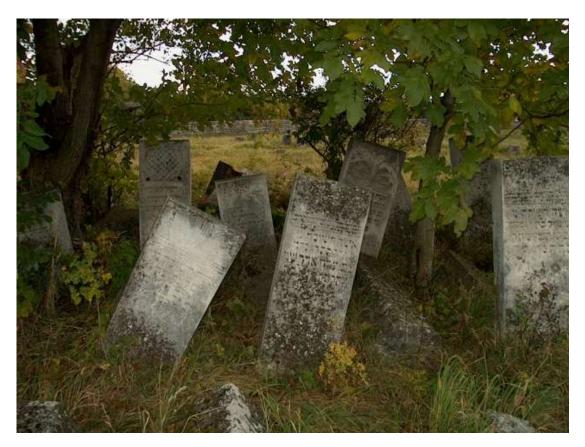
The substantial Jewish cemetery is still in use, but it is poorly maintained, with only occasional clearing or cleaning. The masonry wall that surrounds it is broken in many places. The cemetery's size is about 10,000 square meters and there are more than 100 gravestones still visible, but more than a quarter of these are toppled over or broken.

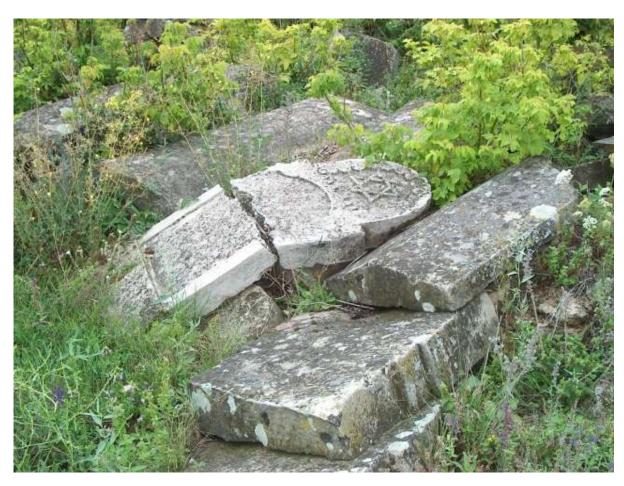
The 5,000 square meter area of the Jewish cemetery in Markuleshti is surrounded by a broken masonry wall. The cemetery contains more than 1,500 stones which date from the 18<sup>th</sup> century. The site has been neglected, however, and more than 75% of the stones are broken or toppled. The cemetery is rarely visited and there is no regular caretaker. The area is overgrown and the site has had some vandalism in recent years.

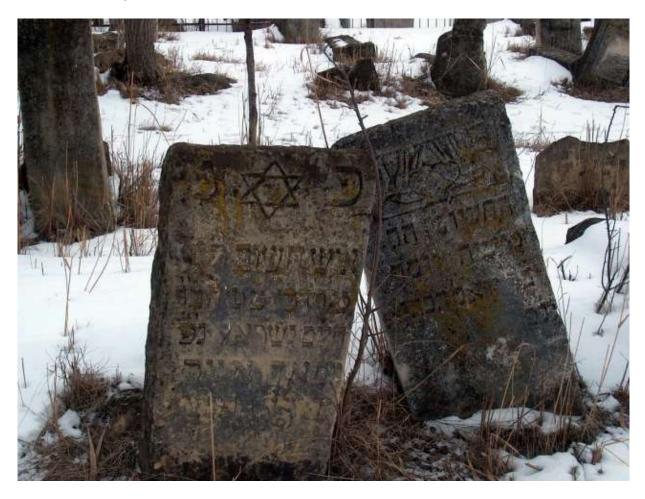
The cemetery occupies an area of approximately 20,000 square meters with more than 100 gravestones still visible, with fewer than 25% toppled or broken. The oldest gravestones on the cemetery are datable from the second half of 19<sup>th</sup> century. The cemetery is surrounded by a broken fence and row of bushes. There is no permanent caretaker, and no maintenance or restoration work has been done in recent years. The remaining three Jews in the town do not have the means to tend the site. The vegetation overgrowth is a serious threat to the graves.

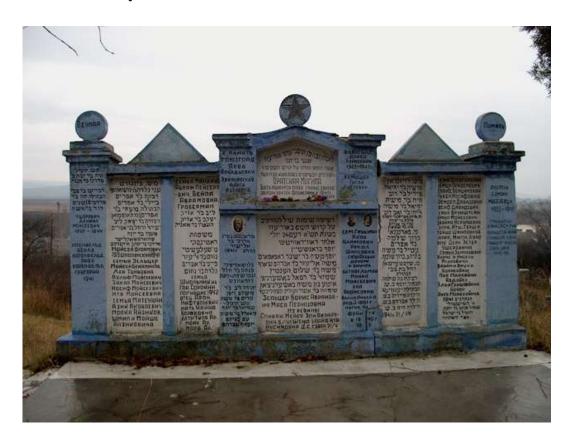
The cemetery is approximately 400,000 square meters and it is surrounded by a broken fence with a gate. The cemetery contains monuments to Jewish soldiers and Holocaust victims, as well as about 3,500 grave stones, of which more than half are toppled or broken. Some of the stones date back to the 17<sup>th</sup> century. The cemetery is still in use, but is only occasionally cared for. There has been frequent vandalism and problems with vegetation overgrowth. The site is located on a soil slip zone as well, so there is the constant problem with soil erosion and the possibility of landslides. A project was undertaken by municipal authorities to strengthen the slope at one point, but it was cut short due to lack of funding.

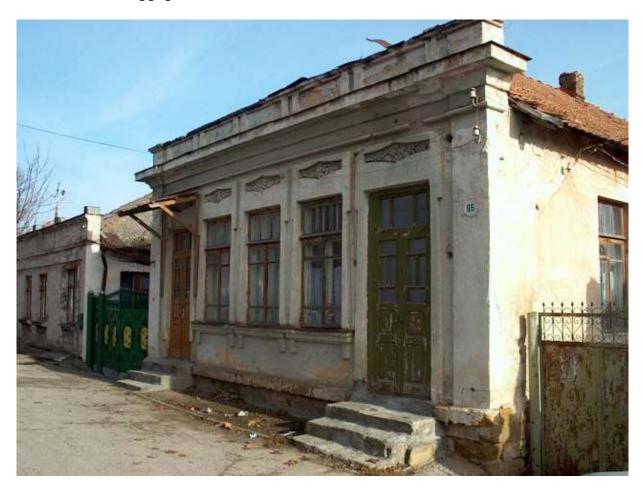
The building, which presently needs extensive restoration, was constructed in the first half of the 20<sup>th</sup> century by local Jewish resident Haim Rappoport for his family. The story of the Rappoport family parallels the history of the Jews in Bessarabia in the last century. In 1941, the Rappoport family was deported to the concentration camp in Dumanovka, Romania where they were kept until 1944. Four of Rappoport's sisters died in the camp, but he and his brother survived. After the war, Rappoport returned to Orhei, where he faced repression and false accusations. In April, 1949 until 1956, the family was exiled to Irkutsk (Siberia) by the Soviet government, and the house was requisitioned by the state. Since Moldovan independence, Rappoport's son Semeon has managed to successfully reclaim the property and it was returned to the family in 2003. The building is not in use at the moment and needs fundamental repairs.

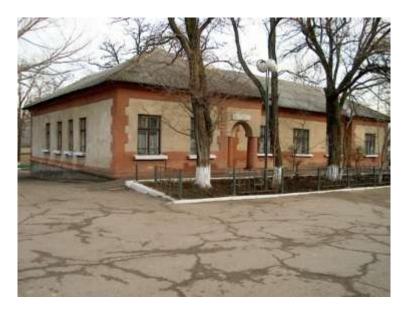
### **Former Jewish Hospital**

Construction of the Jewish Hospital complex began in September, 1934 on the site of the former Jewish hospital, which burned down in 1933. In between 1935 and 1940, the complex operated as a Jewish hospital but served the entire community. Today, the building serves as a regional hospital. It is in fair condition, and is maintained. For the most part, the main buildings have preserved their original exterior form and appearance, but inside they have been remodeled and modernized several times.

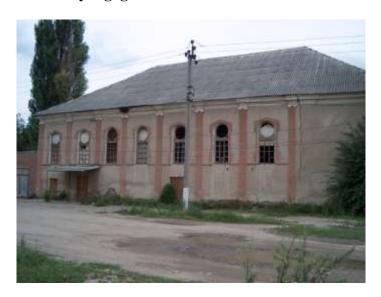
The Ataky synagogue was built in the middle of the 19<sup>th</sup> century. The building is now owned by the Jewish community but it is no longer in use. After the Second World War,

it became the local culture center ("Palace of Culture"). The building is in very poor condition.

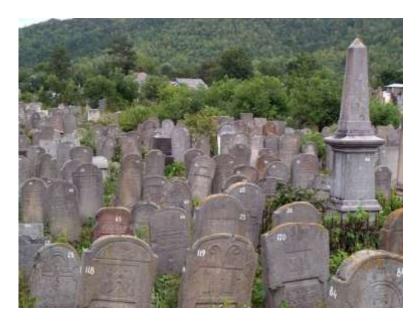
The Jewish cemetery in Otachi is 160,000 square meters and contains more than 500 gravestones, as well as a monument dedicated to the victims of the Holocaust. The oldest gravestones are from the nineteenth century. The cemetery is surrounded by a broken masonry wall; fewer than 25% of the stones are toppled and broken. The site has a regular caretaker, but the vegetation overgrowth is a constant problem. Restoration work to patch the broken stones and clear the vegetation was carried out between the years 2000 and 2004.

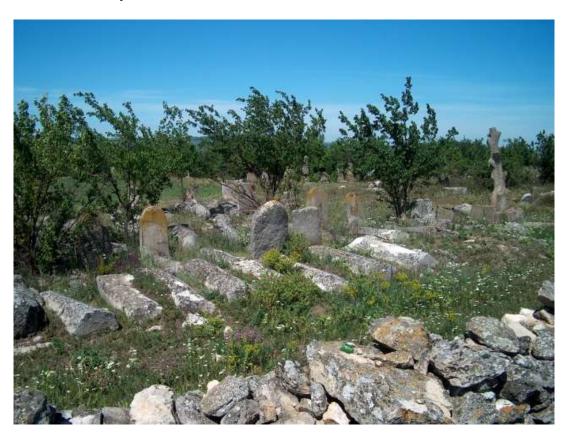
The Jewish cemetery is surrounded by a broken masonry wall. It contains more than 500 gravestones dating back to the 19<sup>th</sup> century and approximately 25% are toppled or broken. The cemetery is no longer in use, and is only rarely visited by local residents. There has not been care for the site in a long time. Constant overgrowth threatens the condition of the gravestones.

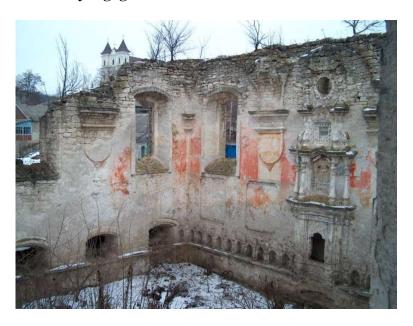
The impressive Baroque-style synagogue, built in 1749, is only a ruin with its outer walls and part of the *Aron ha-Kodesh* (Holy Ark) intact. This synagogue – even in its ruinous state – is architecturally the most impressive Jewish building in Moldova. There has been discussion of removing parts of it, especially the *Aron ha-Kodesh*, for installation at the Jewish Museum in Chişinău.

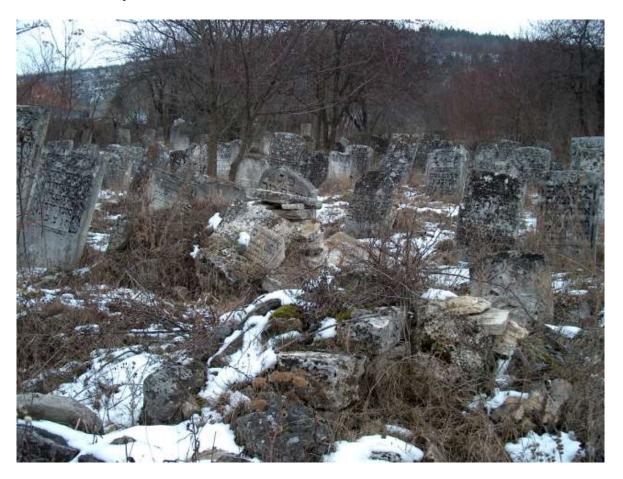
The 20,000 square meter cemetery is surrounded by a ruined stone wall. The cemetery contains more than 5,000 extant gravestones that date from the  $18^{th}$  to the  $20^{th}$  centuries. The site is now deserted and overgrown and more than half of the stones are toppled or broken.

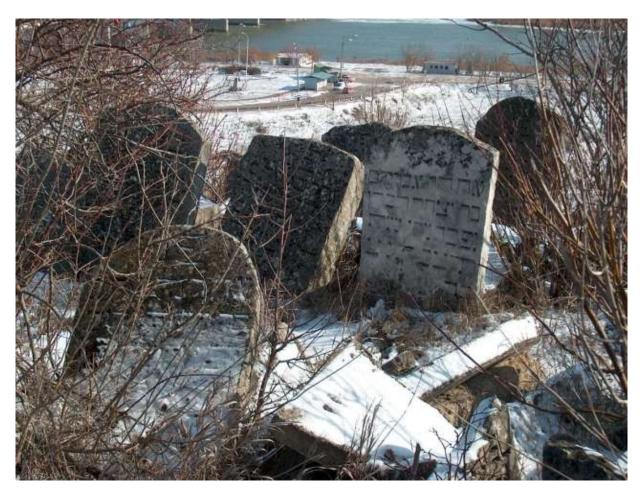
It is almost impossible to locate the cemetery's borders today, as there are no walls or fence and nearby housing developments have encroached upon the cemetery. New building continues to be a problem. There are approximately 500 gravestones still visible, but more may be toppled and out of view. The site does not have a regular caretaker and it has been neglected in recent years. The vegetation overgrowth is a constant problem which threatens the condition of the gravestones. The cemetery has also been a target of vandalism.

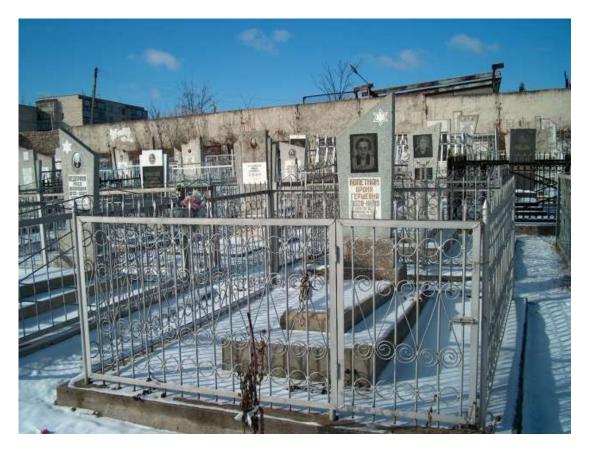
The new Jewish cemetery in Rezina was established in the late 1950s. It is 1,500 square meters in size and contains approximately 300 gravestones. The site has a regular caretaker. Regular conservation and restoration work has taken place, but because the cemetery has been vandalized several times in recent years, the local Jewish community does not have means to continue to repair the damage.

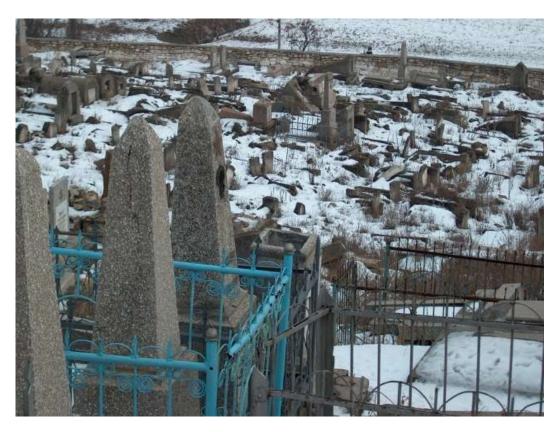
The cemetery covers an area of 16,000 square meters and is surrounded by a new stone wall with a gate. It contains about 5,000 extant gravestones. More than half of these are toppled or broken. The oldest stones are from the 18<sup>th</sup> century. Restoration efforts started in 2001 and are still underway. At the time of the site visit for this survey, more than 100 stones had been restored.

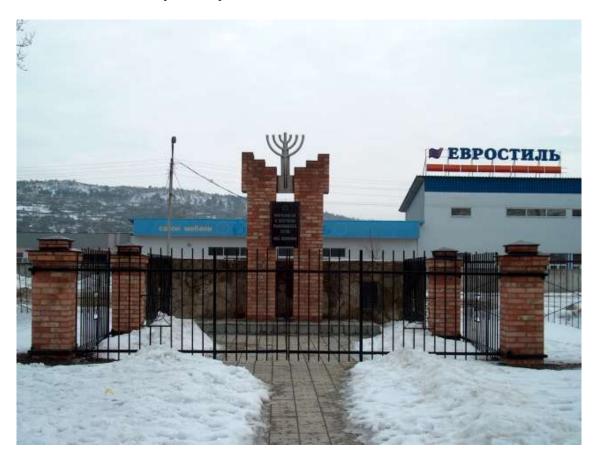
### Memorial to the Martyrs of Rybnitsa Ghetto

A memorial was dedicated on April 4<sup>th</sup>, 2004 to commemorate the victims of the Nazi persecution in Rybnitsa. The monument was constructed on the site of the pre-war Jewish district, which was transformed into a Jewish ghetto during the war, and where 5,000 Jews were murdered by the Nazis. The district has since then been transformed into commercial zone.

Former ghetto prisoners, eyewitnesses, officials and guests from abroad attended the dedication ceremony. The monument consists of free-standing twinned brick piers, which are linked at the top by a menorah. A commemorative plaque is affixed midway up the monument. The monument is surrounded by a fence of brick and metal. The site is approached by a paved walkway.

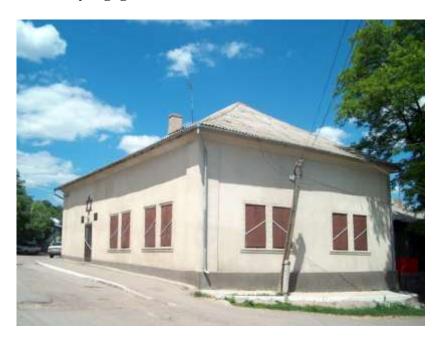
## **Hasidic Synagogue**

Constructed in 1804, the synagogue has been returned to the Jewish community of Soroca. The building is in good condition.

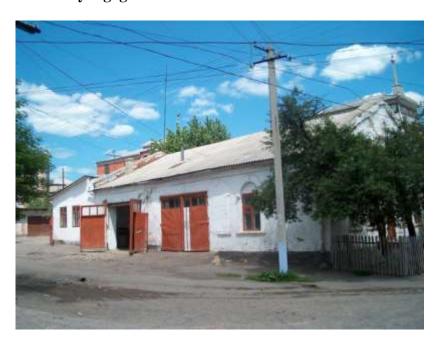
## **Former Synagogue**

Constructed in the beginning of the  $20^{th}$  century, the former synagogue is currently owned by municipal authorities who have turned it into a fire station.

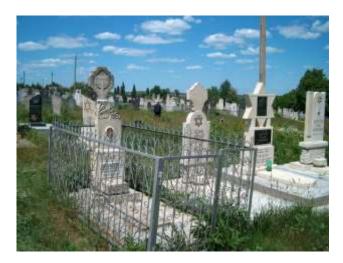
The Jewish cemetery in Soroca is 1500,000 square meters, and is surrounded by a broken wall with a gate that needs to be repaired. It contains a monument to Holocaust victims and about 20,000 gravestones. The oldest gravestones are from the 18<sup>th</sup> century and more than half of them are toppled or broken. The cemetery is still in use and it has a regular caretaker. It is occasionally vandalized, but the site is cleaned, cleared, and restored twice a year. The cemetery is visited frequently.

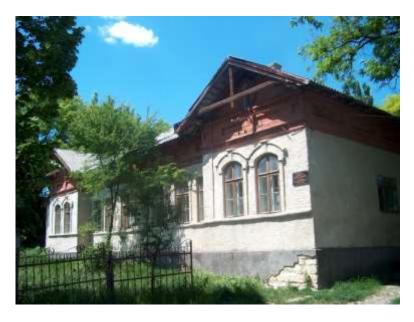
The Jewish Hospital was constructed in the middle of the 19<sup>th</sup> century. The building is currently owned by municipal authorities and is no longer operational. It is in very poor condition.

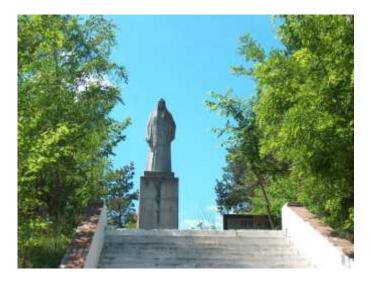
## Monument to the Victims of the Second World War

The monument to the Victims of the Second World War is a protected historical landmark. Municipal authorities maintain the site.

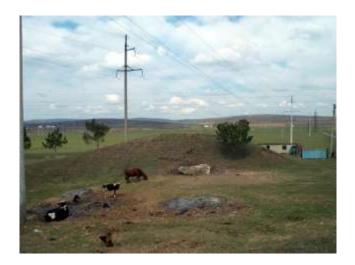
#### **Execution Sites**

The Jewish population of Telenesti was murdered July 14-15, 1941. The two execution sites are located near the town, where according to eyewitnesses, more then 400 people were killed or buried alive. The first mass execution of about 250 people was carried out near Teleneşti in the direction of Inesti and Ratus. The other executions were carried out one and a half kilometers from Teleneşti, in a ravine towards the village of Budei. According to the local residents, about 150 people were killed at the top of the ravine and the corpses were dumped down below. The next day the local residents buried them in three mass graves. On March 22<sup>nd</sup>, 1945 the corpses in both mass graves were exhumed, but authorities were not able to identify the bodies. Both sites are currently neglected. No signs or monuments commemorate the terrible events. Now the sites are used for animal grazing and dumping of waste.

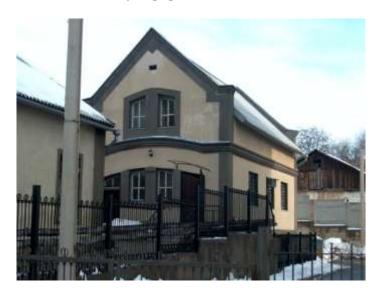
## "Hesed Hana" Synagogue and Jewish Center

Since 2001, the former synagogue building has served as the Jewish welfare and cultural center called "Hesed Hana." The building was recently renovated and is now in very good condition. Following the Second World War, the synagogue was rented for apartments. It was returned to the Jewish Community in 1995. The reconstruction was funded by JDC and the Pozner Foundation.

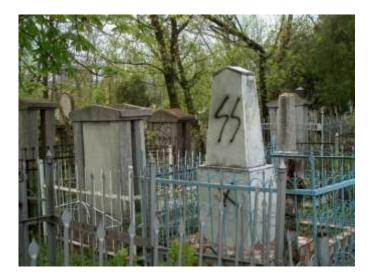
## **Jewish Cemetery**

The cemetery contains around 2,000 gravestones from the 19<sup>th</sup> and 20<sup>th</sup> centuries. There are also monuments to the victims of the Holocaust and to the repressions that took place between 1937 and 1938. The cemetery is surrounded by a broken masonry wall.

A restoration project was carried out in 2001, but in March 2004, more than 70 tombstones were vandalized. Some were smashed and anti-Semitic slogans and swastikas were painted on others. The cemetery is not in use and has no regular caretaker.

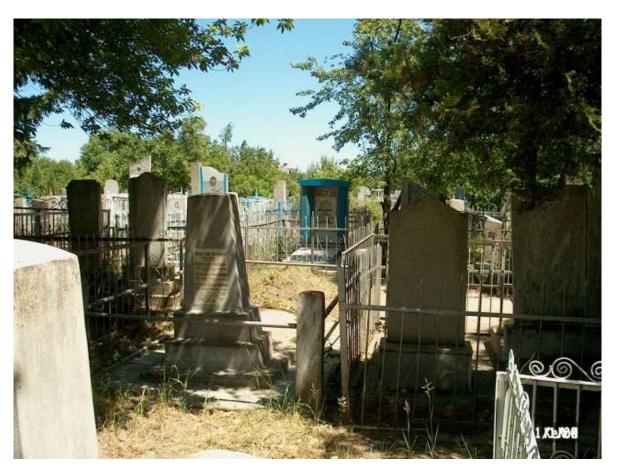
# **Jewish Cemetery**

The new Jewish cemetery in Ungheni is now part of the municipal cemetery. Approximately 100 gravestones are located on the 2,400 square meters, which was designated for Jewish burials in 1958, after the old Jewish cemetery in the town was closed and signs of it demolished. The stones at the new cemetery are all in good condition. The cemetery has no regular caretaker, but the area is occasionally cleaned and cleared by local individuals. Vegetation overgrowth is only a seasonal problem.

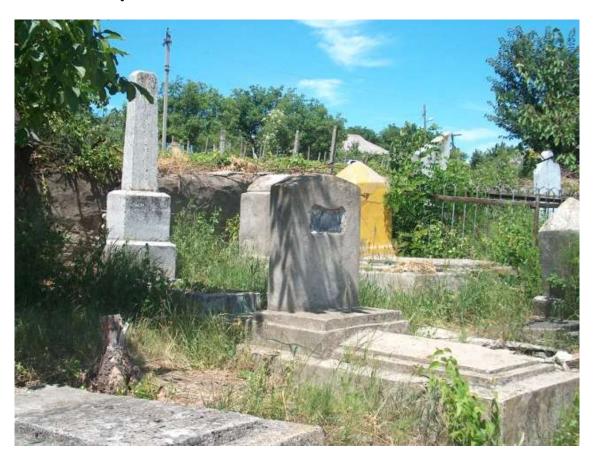
## **Jewish Cemetery**

The Jewish cemetery has approximately 500 gravestones. Fewer than 25% of these are toppled or broken. The oldest gravestones date from the 18<sup>th</sup> century. The cemetery is no longer in use and is rarely visited. There is no regular caretaker and there has been no restoration work in recent years. The vegetation overgrowth is a seasonal problem which prevents access to much of the cemetery.

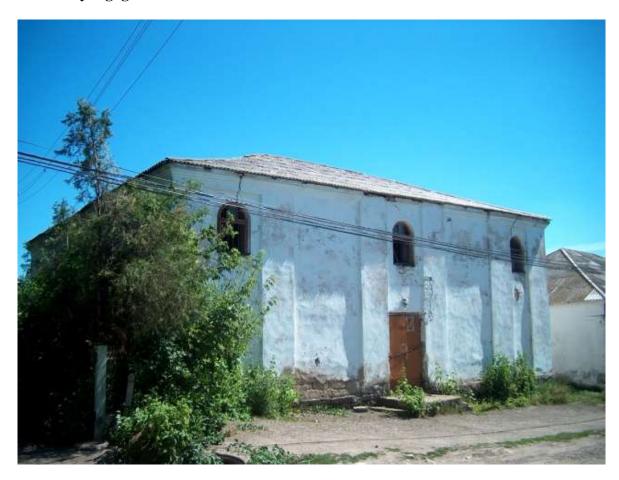
#### Former Synagogue

The former synagogue, which may date to the late 18<sup>th</sup> or early 19<sup>th</sup> century, is a rectangular building, two stories tall, with an exterior articulated with wide, flat, full-height applied pilaster strips. The entrance is through a small rectangular door set in the narrow central bay. The building appears to have been constructed in at least two phases, with the front (street) block abutting another large rectangular section to the rear. Three round-head arched windows are set in the upper portion of the street façade, one over the entrance in the narrow central bay the other two at the same level in the narrow corner bays. The building is owned by the village cooperative but is not in use. After the Second World War, the building was turned into a warehouse, but since the collapse of the Soviet Union it has been deserted. It is in very poor condition, with several visible cracks running through the façade.

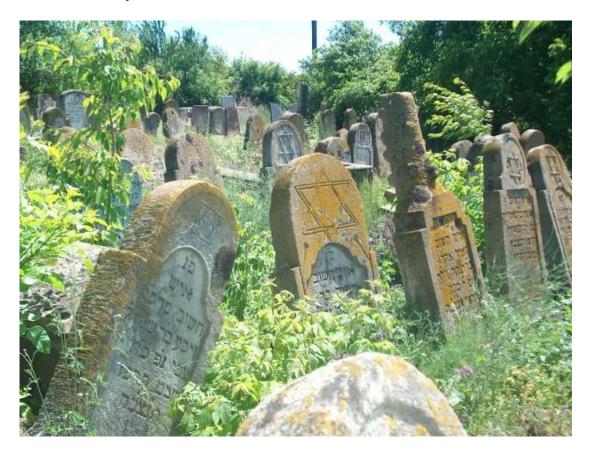
# **Jewish Cemetery**

No longer in use, this 2,000 square meter cemetery is surrounded by bushes and trees. It contains more than 1,000 gravestones, some dating from the 18<sup>th</sup> century. Almost three-quarters of the stones are toppled or broken. The cemetery does not have a regular caretaker and has not recently been maintained. Vegetation contributes to its decay.
